Alignment of the Atmospheric Visibility Monitoring Telescope

K. Cowles and D. Erickson
Communications Systems Research Section

Alignment of the first Atmospheric Visibility Monitoring telescope has revealed errors in mount design, mount manufacture, software, and electronics. This article discusses error sources and solutions, and realignment results. Alignment requirements for operation are also presented. The telescope now operates with the desired accuracy and repeatability.

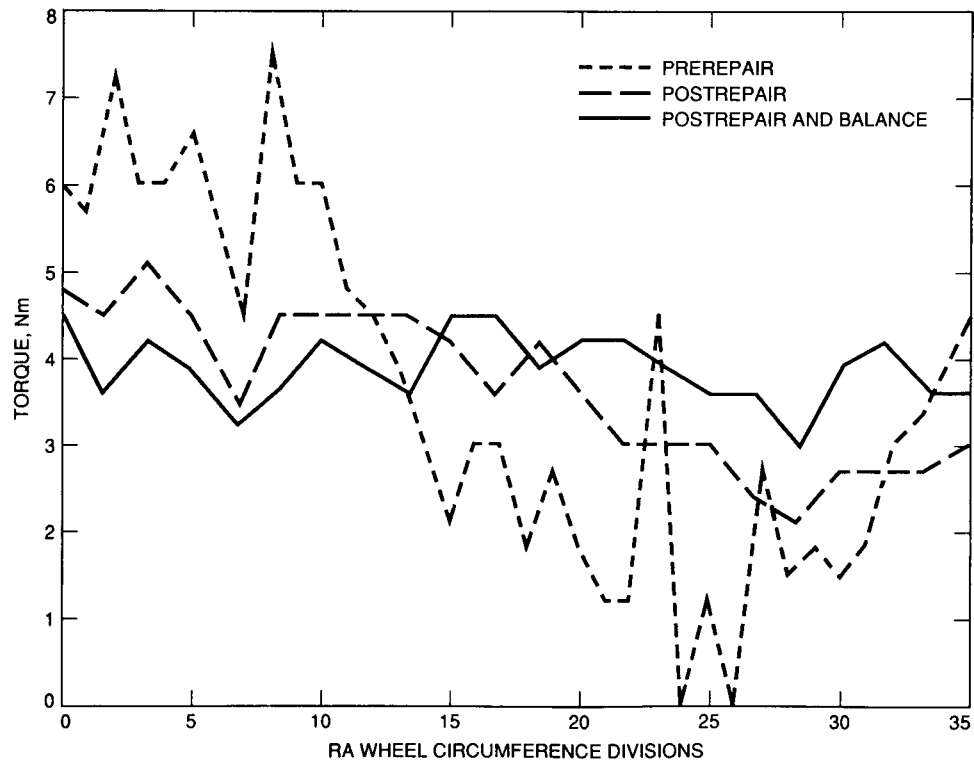
The right ascension wheel was balanced statically by measuring the torque required to move the wheel with a torque wrench. Magnetic counterweights were attached to the wheel in an attempt to compensate for torque differences. Some errors were not able to be eliminated using counterweights. These errors have been attributed to errors in the right-ascension wheel assembly, which was found not to be concentric with the South Pole bearing shaft. This caused uneven preloading, requiring more torque to turn the wheel at certain points. Figure 1 shows the torque necessary to move the right ascension wheel before it was repaired. The large peaks on the prerepair curve display the preloading effect. This error was also seen in alignment. When moving in right ascension where the wheel corresponded to a peak on the curve, larger positional errors were seen in locating the next star.

The curves in Fig. 1 showing conditions following repairs indicate that errors have been reduced by the ma-

Fig. 1. The torque necessary to move the right-ascension wheel before repair, after repair, and after repair and balancing.

chining of the right-ascension wheel. Balancing following the machining has resulted in a more even amount of torque necessary to drive the wheel.

The right-ascension wheel assembly for the third telescope was remachined by the manufacturer to repair a damaged surface. While under repair, it was discovered that the south-pole bearing shaft was not concentric with the right-ascension wheel. It was determined that the preloading of the right-ascension wheel on the first telescope was probably caused by a similar problem. The first and second right-ascension wheels were then sent for repair. These wheels were also found not to be concentric. The center of the wheel for the first telescope was off by $3/8$ in. Repairs were made to both of the wheels.

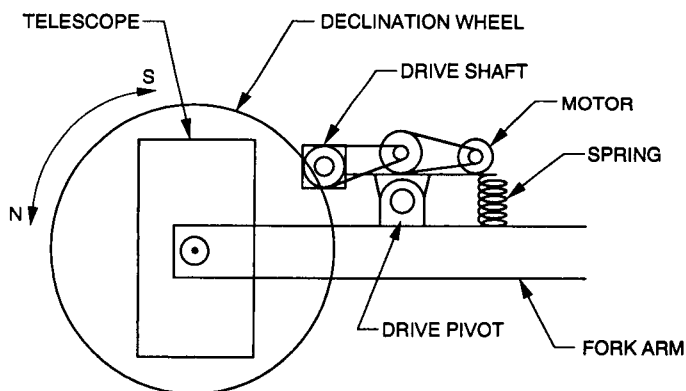
A static balance of the declination wheel was done separately from the alignment procedures. During the alignment procedures for the declination axis, the telescope appeared to be weighted more heavily to the south. Addition of weights to the north did not appreciably change the errors. Theoretically, if the telescope were heavier to the south, it would step too far south when moving south, and not far enough north when moving north. Changing the weights had little effect, however.

A compression spring preloads the drive shaft of the declination wheel. Decreasing the spring tension decreased the south-going error. If the spring tension was decreased to the point where there was still enough tension to drive the wheel without slippage, the telescope still pulled slightly to the south. By using counterweights and lowering the spring tension, the telescope could be moved between stars located between 20 deg N and 20 deg S with smaller errors. However, these errors were nonrepeatable, differing by up to 1.5 arcmin when traveling from north to south. This range limits the available area of the sky considerably. The problem has been attributed to improper preloading of the declination wheel, as seen in Figs. 2 and 3. Figure 2 shows the configuration of the declination drive. Figure 3 indicates the direction of force from the drive shaft onto the declination wheel. Figure 4 indicates the direction of the force that should be applied for proper preloading. Figure 5 indicates how the drive could be reconfigured to achieve this preloading.

Fig. 2. Declination drive of the manufacturer's design.

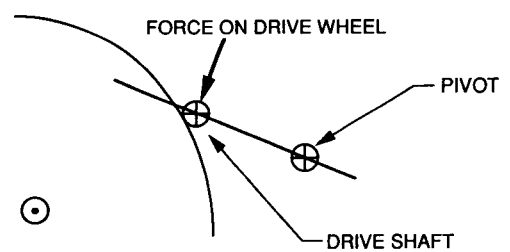
Fig. 3. Directions of force on the declination drive of the manufacturer's design.

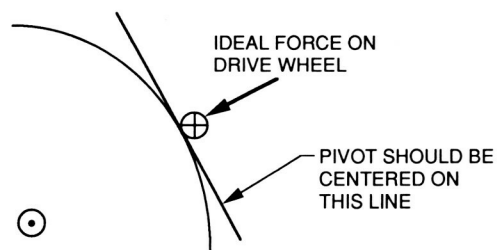
Fig. 4. Directions of force of the modified design for improved acquisition accuracy.

The declination motor assembly and motor shaft have been redesigned and rebuilt, as indicated in Figs. 2-5, to provide proper preloading. A photograph of the present configuration is shown in Fig. 6.

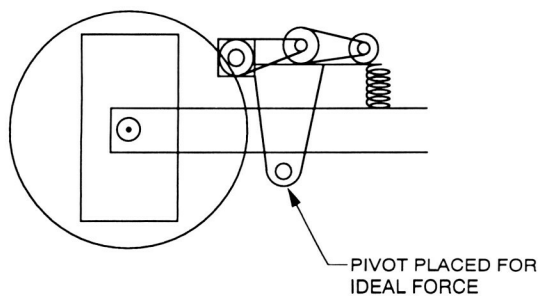
Fig. 5. Declination assembly configuration of the modified design for improved acquisition accuracy.

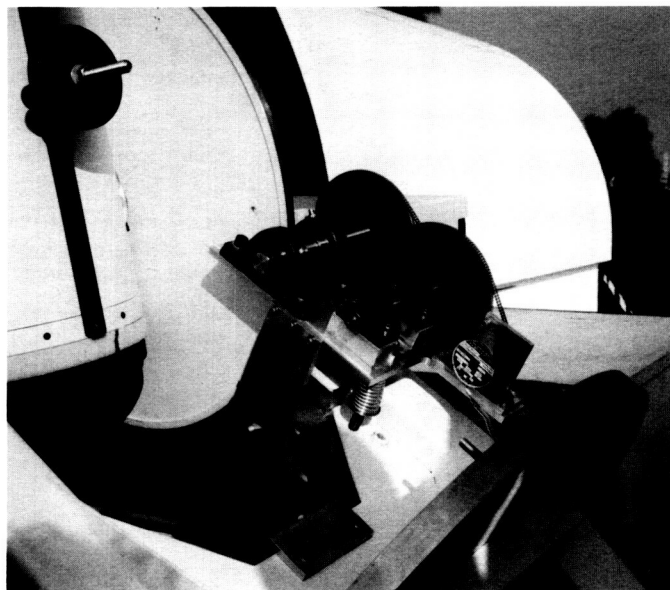
Fig. 6. The present configuration.
